DAYCO AFTERMARKET TECHNICAL INFORMATION

TENSIONER ASSEMBLY
KTBA005, KTBA093, KTBA122, KTBA142,
KTBA149, KTBA212, KTBA244
ENGINES GM 1.6, 1.8 , 2.0 , 2.2

T00001

Engine Codes: C16SEL, C16XE, X16XE, X16XEL, Z16XE, Z16XEP, C18XE, C18XEL, X18XE, X18XE1, Z18XE, Z18XEL, X20XE, X22SE, X22XE, Y22SE.

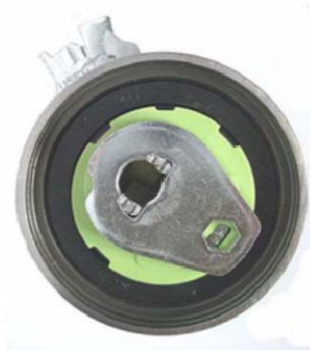
Fig. B

8) With the Allen wrench, rotate the tensioner anticlockwise until the maximum tension is obtained. The indicator should be on the right-hand side of the plate, as shown in **Fig. B**

9) Tighten the tensioner locking bolt to **20-25Nm**

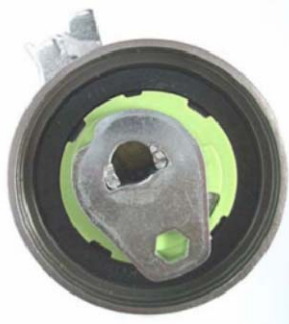
Fig. C

11) Loosen the tensioner bearing, and then rotate the cam clockwise with the Allen wrench until the indicator is aligned with "X".

The hexagonal hole should be in the **5 o'clock** position, as shown in **Fig. C**.

12) Tighten the tensioner locking bolts to **20-25Nm**

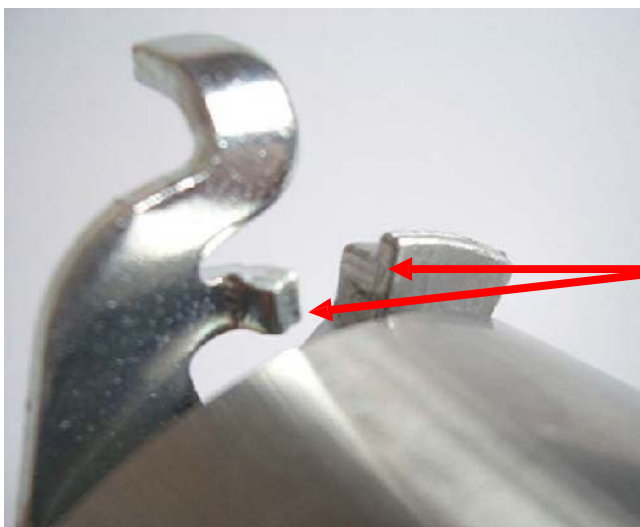
Remember that rotating the tensioner bearing in the wrong direction, with the hexagonal hole in the wrong starting position, without rotating the engine by two turns before and after adjusting the tension, may result in the tensioner arm striking at the end of the stroke and producing a hammering sound until it breaks. The abnormal tension created by this situation will lead to the inevitable collapse of the timing belt.

The presence of damages on these surfaces indicates an abnormal operation of the tensioner following an incorrect assembly.

The incidence of bolt breakage after fitment is due to correct installation procedure not being followed and will not be covered under Dayco warranty.
