## DAYCO AFTERMARKET TECHNICAL INFORMATION

**Subject:** KTBA262 / KTBA262P  
TIMING - KIA CARNIVAL /  
SEDONA / TERRACAN  
TD 2.9 16 v. from 07/2000, CRDi  
16v. from 10/2001  
DAYCO BELT Ref. 94949

**N° :TI0013EN**  
Updated: 09/03/17

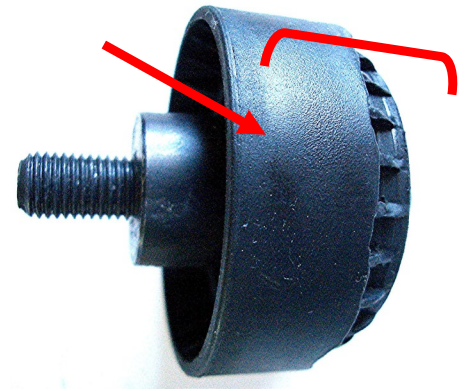
The claim statistics for breaks frequently reports the early deterioration ( 10-15.000 kilometres) of some of the rigid components of the timing control. In these cases, the damage appears in the form of normal wear of the plastic pulley and/or seizure of the bearing, with consequent side deviation and break of the belt.

**Cracked/broken pulley**

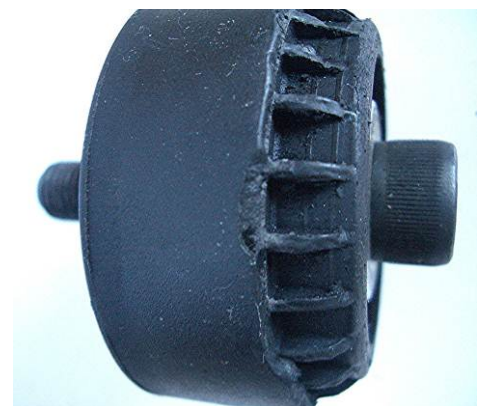
**Cracked/broken pulley**

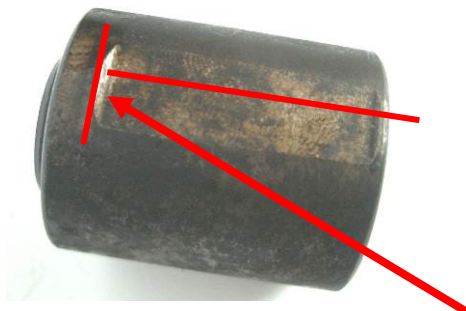
**Seized guide bearing**

A factor that is frequently related to these circumstances is the side deviation of the belt, considered as the cause and not the effect of the subsequent break of the bearing (usually guide bearing). During this stage, the timing belt and the bearing are subject to particular and abnormal stresses of mechanical and thermal nature, related to an alternate bending effort.

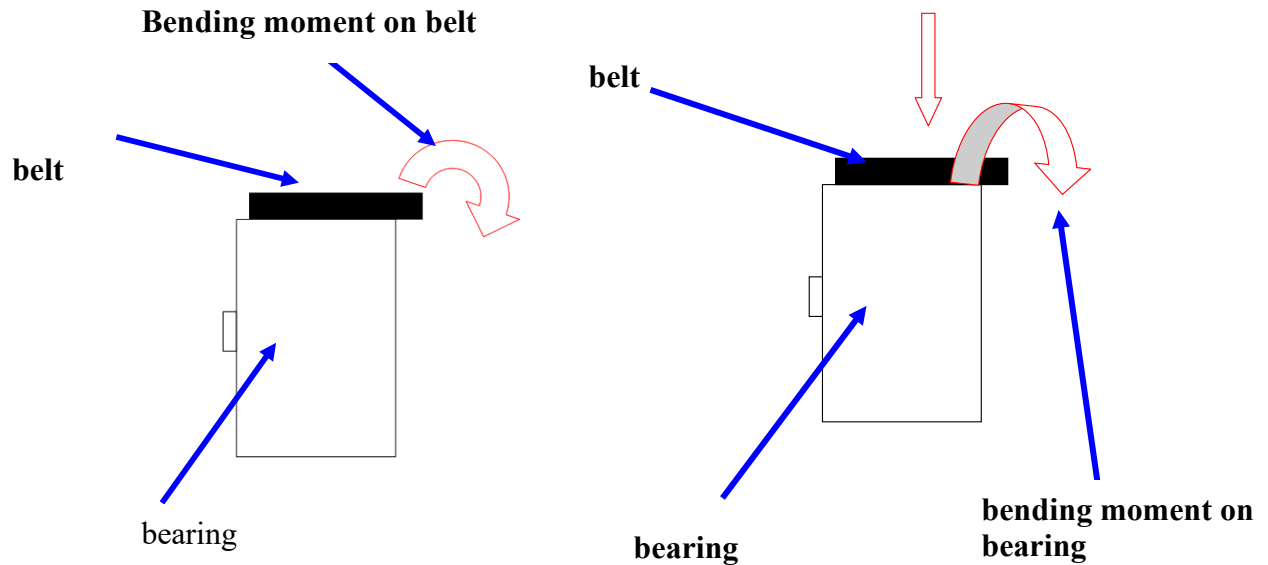
The side deviation cannot be ascribed to the belt characteristics but to external factors, mainly:

- axial misalignment of the components
- lack of parallelism between the axis
- normal wear of the timing pulleys
- loosened tension bearing fastening bolt and reduced tensioning
- anomalous tensioning
- foreign bodies.

The correct tensioning of the timing belt is critical; if the belt is not correctly tensioned, it could “amplify” possible failures of the system for the above-listed reasons.

To avoid this kind of failure, the main steps to be followed for a correct tensioning of the timing belt are described below
