DAYCO AFTERMARKET
TECHNICAL INFORMATION

Subject: **KTBA262 / KTBA262P
TIMING - KIA CARNIVAL /
SEDONA / TERRACAN
TD 2.9 16 v. from 07/2000, CRDi
16v. from 10/2001
DAYCO BELT Ref. 94949**

N° :T10013EN
Updated: 09/03/17

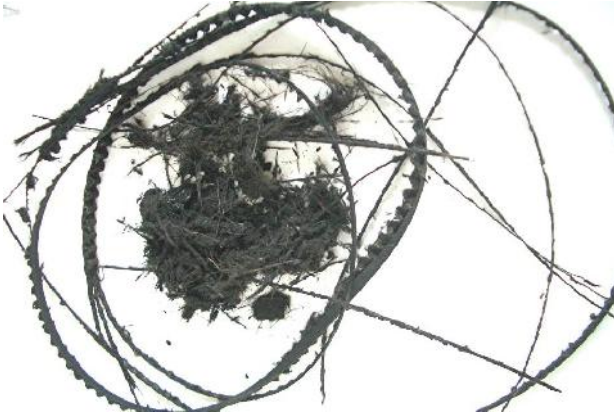
The claim statistics for breaks frequently reports the early deterioration (10-15.000 kilometres) of some of the rigid components of the timing control. In these cases, the damage appears in the form of normal wear of the plastic pulley and/or seizure of the bearing, with consequent side deviation and break of the belt.

Seized guide bearing

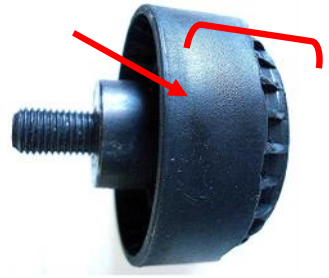
Cracked/broken pulley

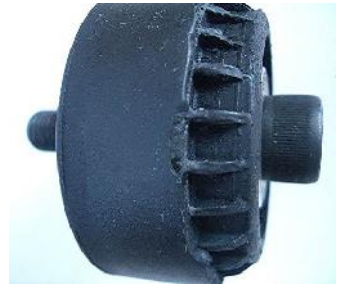
Cracked/broken pulley

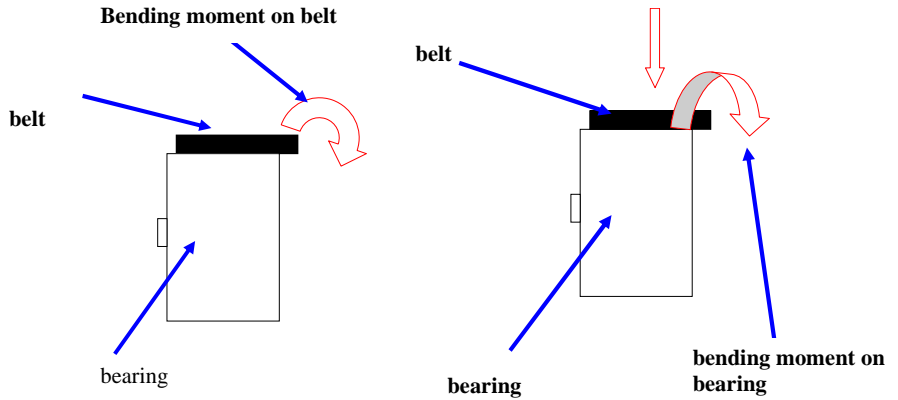
A factor that is frequently related to these circumstances is the side deviation of the belt, considered as the cause and not the effect of the subsequent break of the bearing (usually guide bearing). During this stage, the timing belt and the bearing are subject to particular and abnormal stresses of mechanical and thermal nature, related to an alternate bending effort.

The side deviation cannot be ascribed to the belt characteristics but to external factors, mainly:

-) axial misalignment of the components
-) lack of parallelism between the axis
-) normal wear of the timing pulleys
-) loosened tension bearing fastening bolt and reduced tensioning
-) anomalous tensioning
-) foreign bodies.

The correct tensioning of the timing belt is critical; if the belt is not correctly tensioned, it could “amplify” possible failures of the system for the above-listed reasons.

To avoid this kind of failure, the main steps to be followed for a correct tensioning of the timing belt are described below
