DAYCO AFTERMARKET TECHNICAL INFORMATION

Mitsubishi I4 Timing Drive

T00017

Eng Code: 4G63, 4G64, 4G69 etc

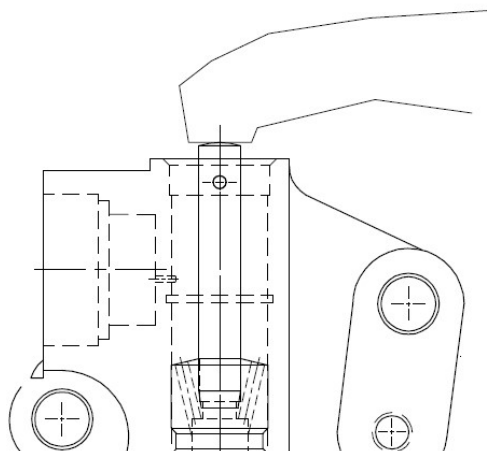
Correct Position

It is also essential that the correct special service tools (SST) referred to in the vehicle manufacturer's procedures are used. This will ensure that the tensioner pulley is set to the correct position in order for the HAT to operate in its intended working range. The correct position for the tensioner actuator should sit such that the interface between the actuator rod and tensioner arm is perpendicular to the direction of travel of the rod. An example of correct and incorrect position is shown below.

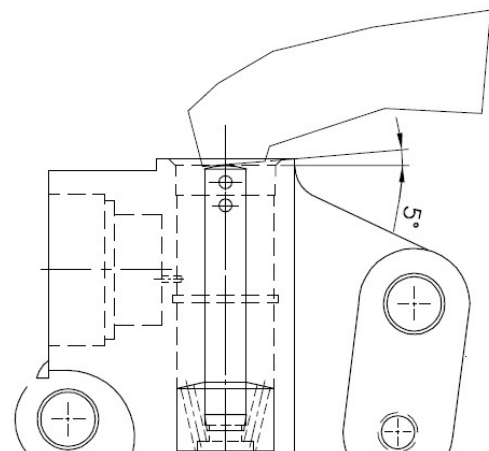
Incorrect Position

If these procedures and SST's are not used, the hydraulic actuator may operate in a range that will not provide the correct tension to the belt. This could cause a timing drive that either becomes noisy in operation or allows the drive to become unstable and lose timing or ultimately lead to failure of the timing drive.

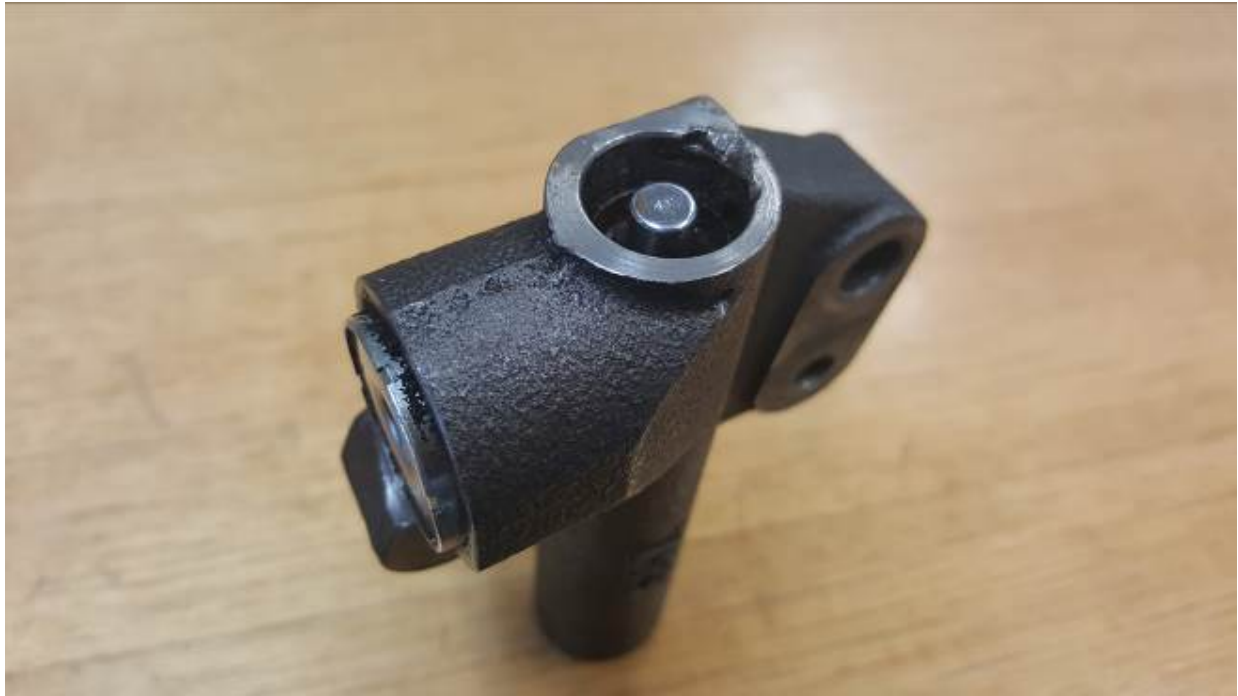
Evidence of HAT failures are actuator rods jammed in retracted position, and hammer marks around the HAT body where the tensioner assembly has come into contact with it. Example of which is shown above.
