DAYCO AFTERMARKET TECHNICAL INFORMATION

TENSIONER ASSEMBLY
KTBA005, KTBA093, KTBA122, KTBA142,
KTBA149, KTBA212, KTBA244
ENGINES GM 1.6, 1.8 , 2.0 , 2.2

T00001

Engine Codes: C16SEL, C16XE, X16XE, X16XEL, Z16XE, Z16XEP, C18XE, C18XEL, X18XE, X18XE1, Z18XE, Z18XEL, X20XE, X22SE, X22XE, Y22SE.

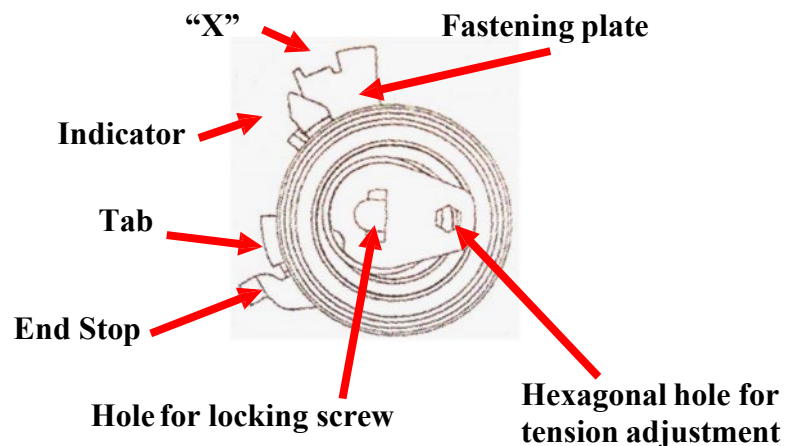
These kits contain mechanical automatic tensioners of the **type shown in the figure**, with a few dimensional differences according to the engine code.
