## DAYCO AFTERMARKET TECHNICAL INFORMATION

**Subject:** KTBA262 / KTBA262P  
TIMING - KIA CARNIVAL /  
SEDONA / TERRACAN  
TD 2.9 16 v. from 07/2000, CRDi  
16v. from 10/2001  
DAYCO BELT Ref. 94949

**N° :TI0013EN**  
Updated: 09/03/17

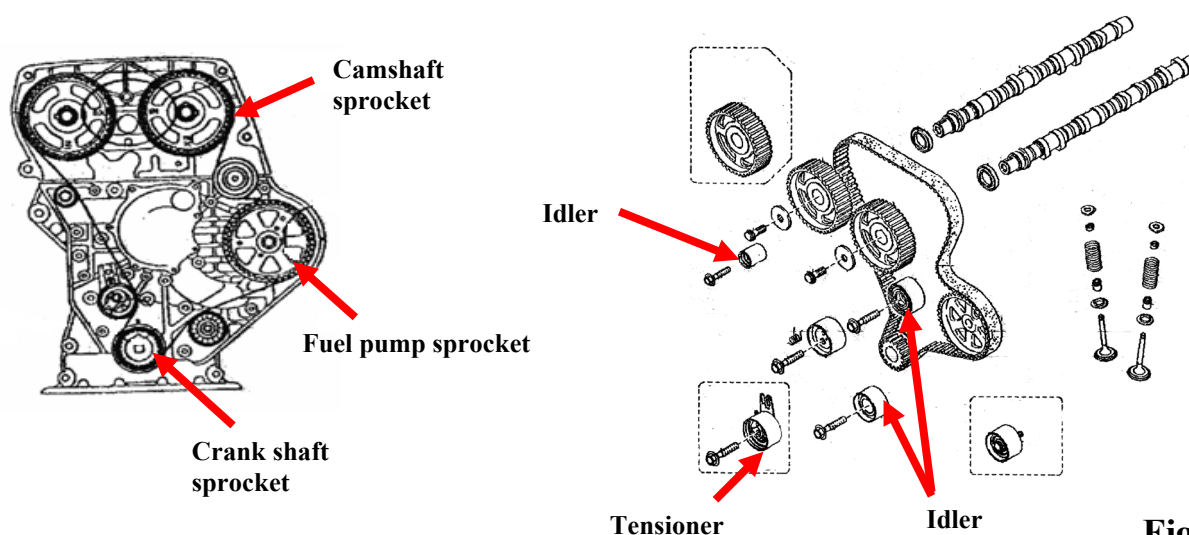
**Fig. A**

In the timing system of the above-mentioned models, the specific routing of the belt involves 8 rotating parts (4 sprockets and 4 pulleys/bearings) as illustrated in Fig. A.

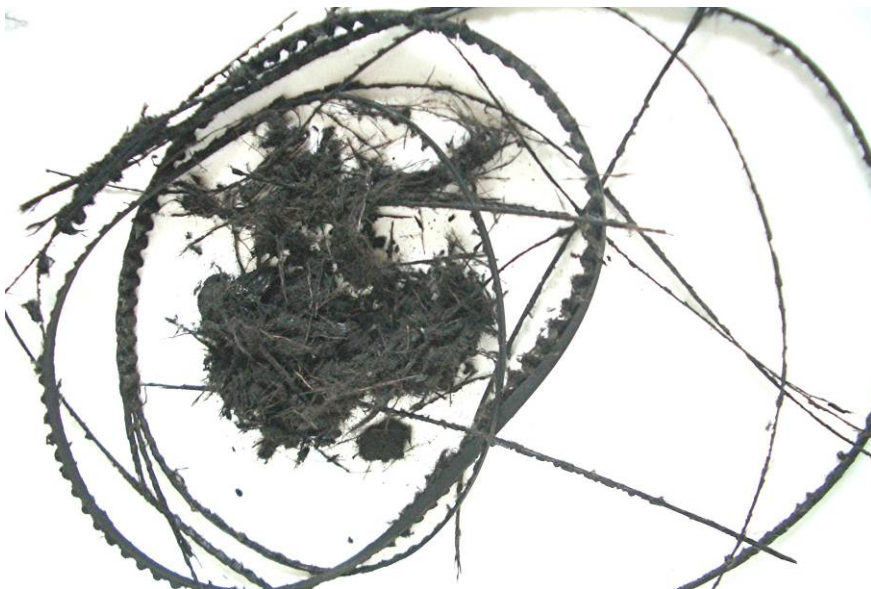
The claim statistics for breaks frequently reports the early deterioration ( 10-15.000 kilometres) of some of the rigid components of the timing control. In these cases, the damage appears in the form of normal wear of the plastic pulley and/or seizure of the bearing, with consequent side deviation and break of the belt.

**Cracked/broken pulley**

To avoid this kind of failure, the main steps to be followed for a correct tensioning of the timing belt are described below

- Install the timing belt, starting from the crank shaft sprocket, anti clockwise, Make sure the belt is taut on the side of the belt that is not tensioned.
- Fit the automatic tensioner as shown in **Fig. B**.
- Pre-tighten by hand the automatic tensioner (**3,9 Nm**)

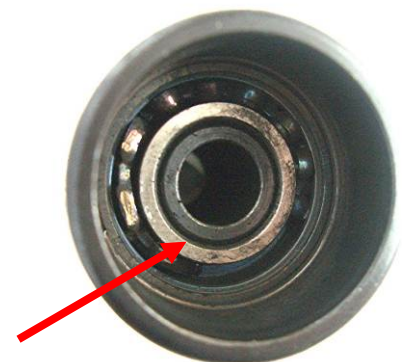
**Seized guide bearing**

A factor that is frequently related to these circumstances is the side deviation of the belt, considered as the cause and not the effect of the subsequent break of the bearing (usually guide bearing). During this stage, the timing belt and the bearing are subject to particular and abnormal stresses of mechanical and thermal nature, related to an alternate bending effort.

The side deviation cannot be ascribed to the belt characteristics but to external factors, mainly:

- axial misalignment of the components
- lack of parallelism between the axis
- normal wear of the timing pulleys
- loosened tension bearing fastening bolt and reduced tensioning
- anomalous tensioning
- foreign bodies.

The correct tensioning of the timing belt is critical; if the belt is not correctly tensioned, it could “amplify” possible failures of the system for the above-listed reasons.
