DAYCO AFTERMARKET TECHNICAL INFORMATION

Subject: KTBA281, KTBA281H
KTBA281HP & KTBA281HP1 TIMING KITS

TI00020
Released 04/10/2016
Revised 01/07/2021

Mitsubishi Challenger/Triton 4D56T

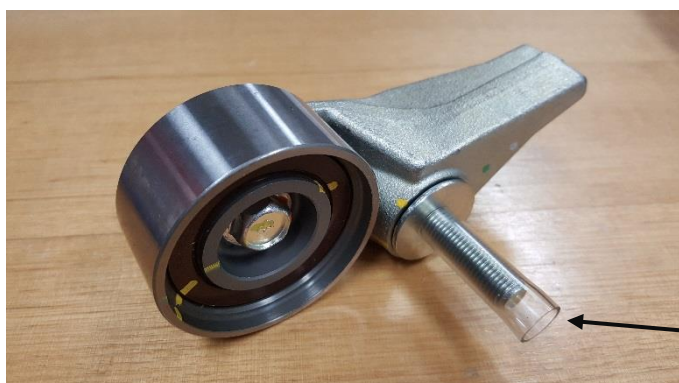
This family of timing kits contains a Timing Tensioner Assembly (Dayco P/N KT190) for the main timing drive, and is supplied with a special Allen Shoulder Bolt held captive by a plastic sleeve (refer below).

Plastic captive sleeve as supplied on bolt

Upon removal of the plastic captive sleeve, it is important that the spacer washer remains in its intended place on the assembly and is included when fitting to the engine. Further, the bolt must be tightened down to a torque of **48Nm +/- 6Nm**. Once fitted, check that the tensioner assembly pivots freely about its mounting point.

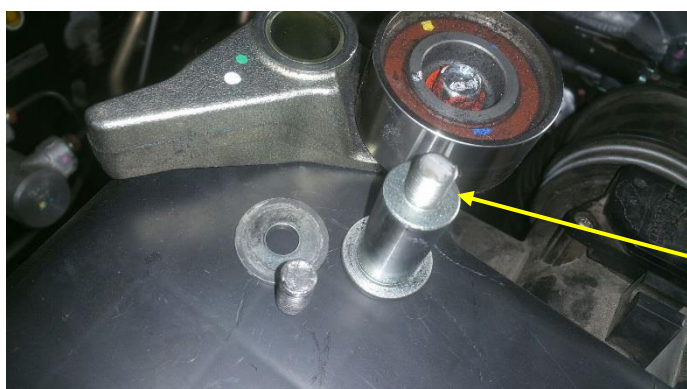
If these additional procedures and checks are not carried out there is a potential for the mounting bolt to fail through fatigue, resulting in engine damage (an example of such a failure shown in photo left). Any claims with evidence of this type of failure will not be covered under warranty.

Mounting bolt failure through fatigue

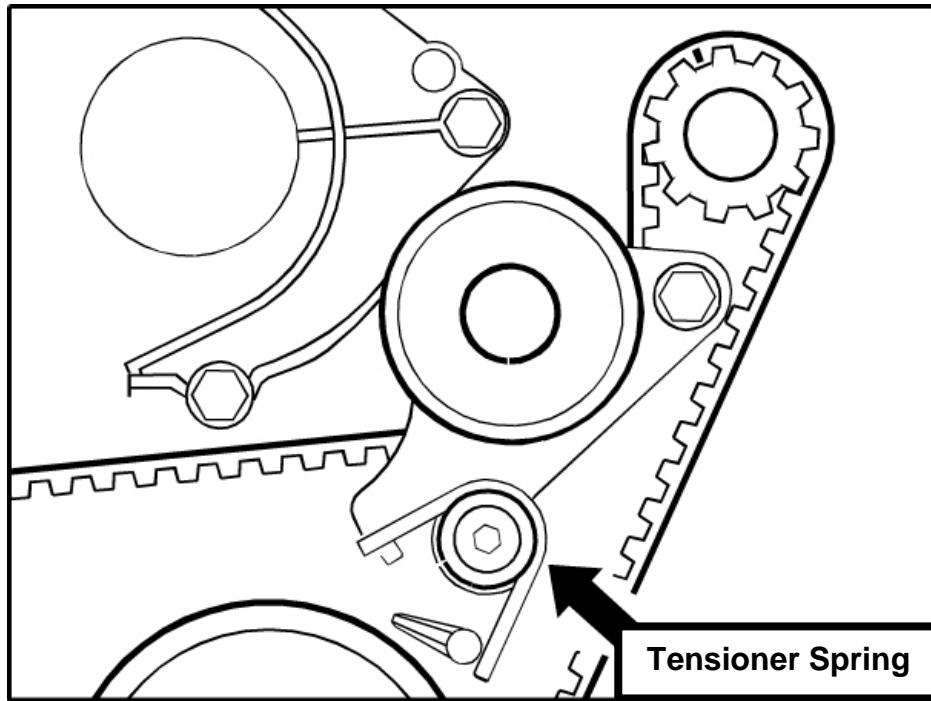
Balance Shaft Timing Belt Installation Information

Failure to observe correct installation procedures surrounding the balancer timing drive can result in premature failure of components due to improper tension, notably:

1. Timing Belt jumping teeth or shearing off teeth
2. Timing Belt not running true, and interfering with main camshaft timing belt
3. Balancer Timing Belt Tensioner failure

When installing new balancer timing drive belt and tensioner, ensure there is no slackness on tension side, and specifically:

- The balancer timing belt tensioner spring is fitted with the shorter leg facing towards the water pump
- Tighten the tensioner assembly, first the hex socket head bolt to 20Nm, then the hex head bolt near the top balancer shaft sprocket to 23Nm. It is essential that this sequence be adhered to.
- Check the belt tension by deflecting the timing belt pushing inwards with finger at a point midway between the top balance shaft sprocket and crankshaft driving sprocket. Deflection should be 4-6mm, if outside these parameters then the sequence of installation should be repeated.
